Human Factors and Design Failures in the British Airways Flight 5390 Incident: Lessons for Medical Error Reduction and Healthcare Safety Systems

Abstract— On 10th June 1990, British Airways Flight 5390 was a flight from Birmingham in England to Malaga in Spain at 07.20 UTC. In this flight, Captain Pilot Tim Lancaster was blown out and was injured from the cockpit window at 17.300 feet, -17 Celcius. Information was given about the investigation of the crash, the faulty design, and the importance of human factors in aviation.

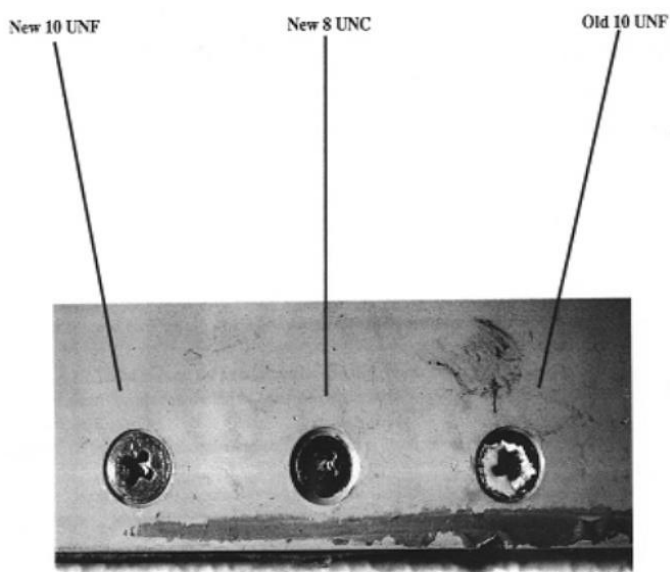
officer was trying to control the flight. Control was getting more difficult because the captain held the control column with his legs, the auto-pilot was disconnected and it pushed down the aircraft. When the cabin crew held their captain, they thought to release his body. However, they renounced due to damage to the engines, wings, or its body. The first officer made a decision and he communicated an air traffic controller in Southampton for an emergency landing. He successfully landed the plane at 08.55 despite the maximum landing weight. He was taken to the hospital, saved and recovered. He was starting to fly again after 5 months.

According to the documentary and the investigation report, recently the glass was changed and the aircraft maintenance engineer used different bolts which were different lengths and diameters with low torque because he worked at 05.00 a.m. and ignored maintenance procedure. Also, a person who works at the warehouse did not check the bolts and a functional control mechanism was not performed. Furthermore, according to Figure 1, the main reason is that the human factors issues raised by the fitting of incorrectly sized bolts to the windscreen of this aircraft. The importance of human factors has proven itself once again [2]. Module 9 for aircraft maintenance engineers should be given periodic

training called Human Factors after this incident [3]. The design of fitting glass screws could be improved and double-check could be required in maintenance. Commercial flight pilots were started to give pressure training after this incident. In addition to this, the fuel drain system could be improved due to the maximum landing weight. Since, if the speed of fuel drain system was increased, they could be landing easily.

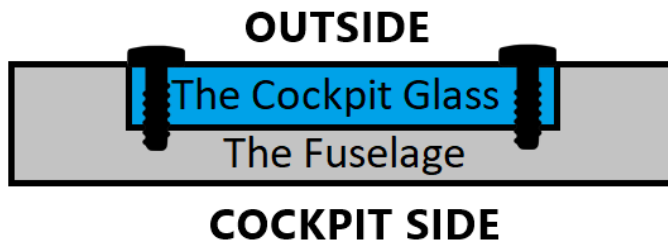
Fig. 2. Design of BAC-111's windshield

When the incident is examined for the faulty manufacturer, removing or installation of the windshield has to perform at outside because of designing and it poses difficulties for aircraft maintenance engineers, so

it increases the risk of making mistakes during maintenance in Figure 2. Besides, the strength was reduced due to the positioning of the glass in front of the fuselage.

If the design was as in Figure 3, windshield mounting could be easily done. Since location of screw slots and rechanging the glass from inside the cockpit provide convenience for aircraft maintenance personnel without the need for a ladder. The windshield which was between the fuselage and cockpit creates more durability.
